NASA Contractor Report 3715

**DC-10 Composite Vertical Stabilizer
Ground Test Program**

**J. M. Palmer, Jr., C. O. Stephens,
and J. O. Sutton**

**CONTRACT NAS1-14869
AUGUST 1983**

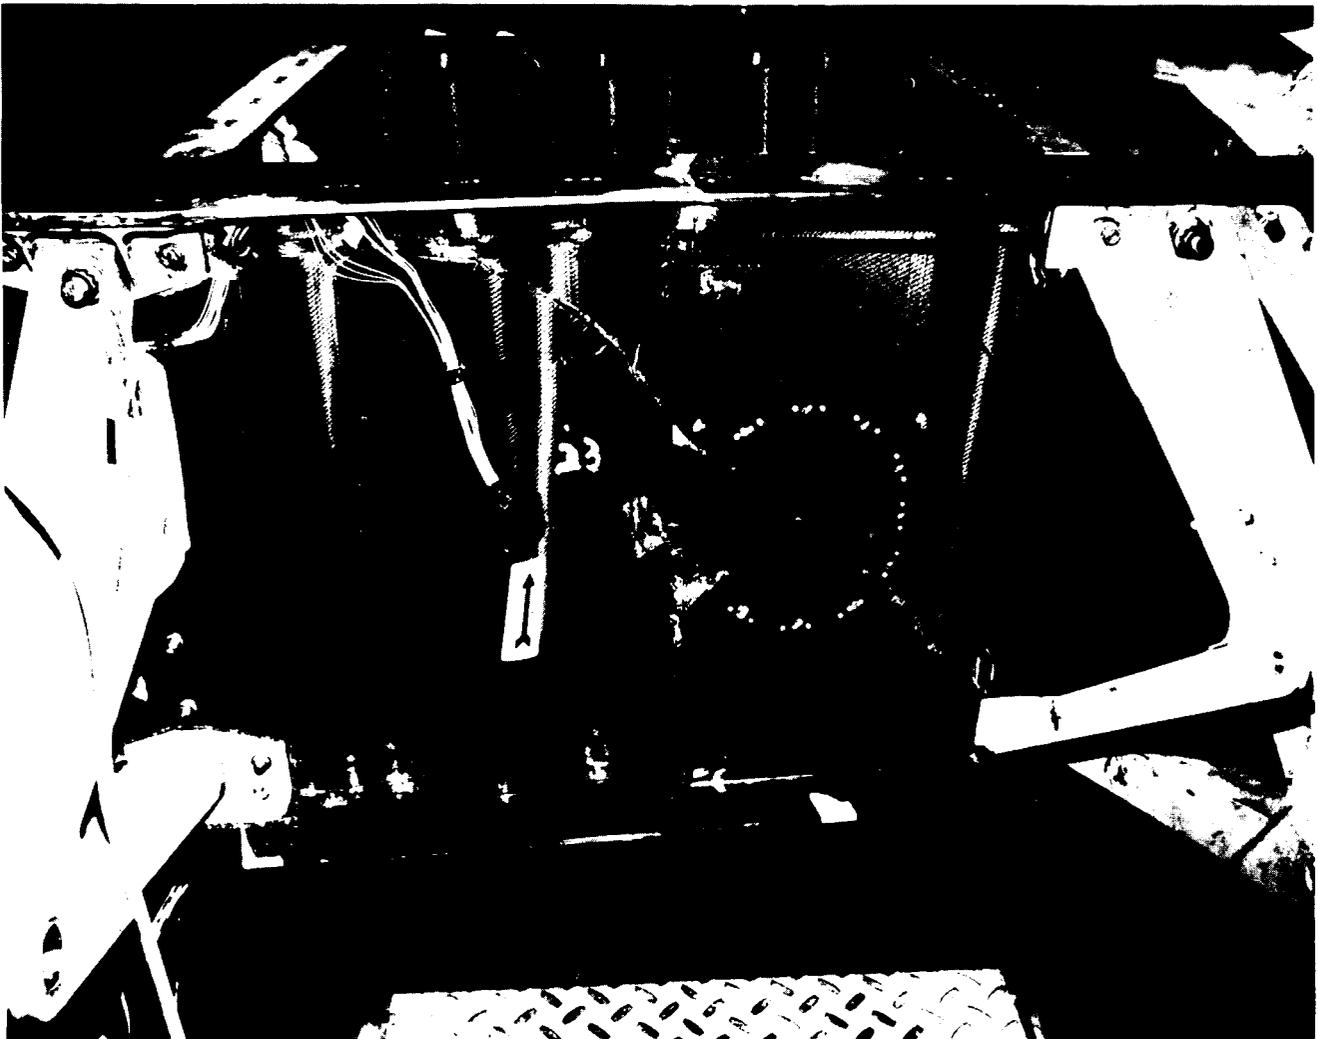
FIGURE 19. FAILURE OF REAR SPAR WEB IN GROUND TEST UNIT

Posttest visual examination of the specimen revealed structural failures in the rear spar web in the bay above the lower actuator cutout (Figure 19) and failures in the left-hand (compression side) skin panel. Following this preliminary survey of the damage, the specimen was removed from the test jig and returned to the manufacturing assembly area for more detailed damage assessment.

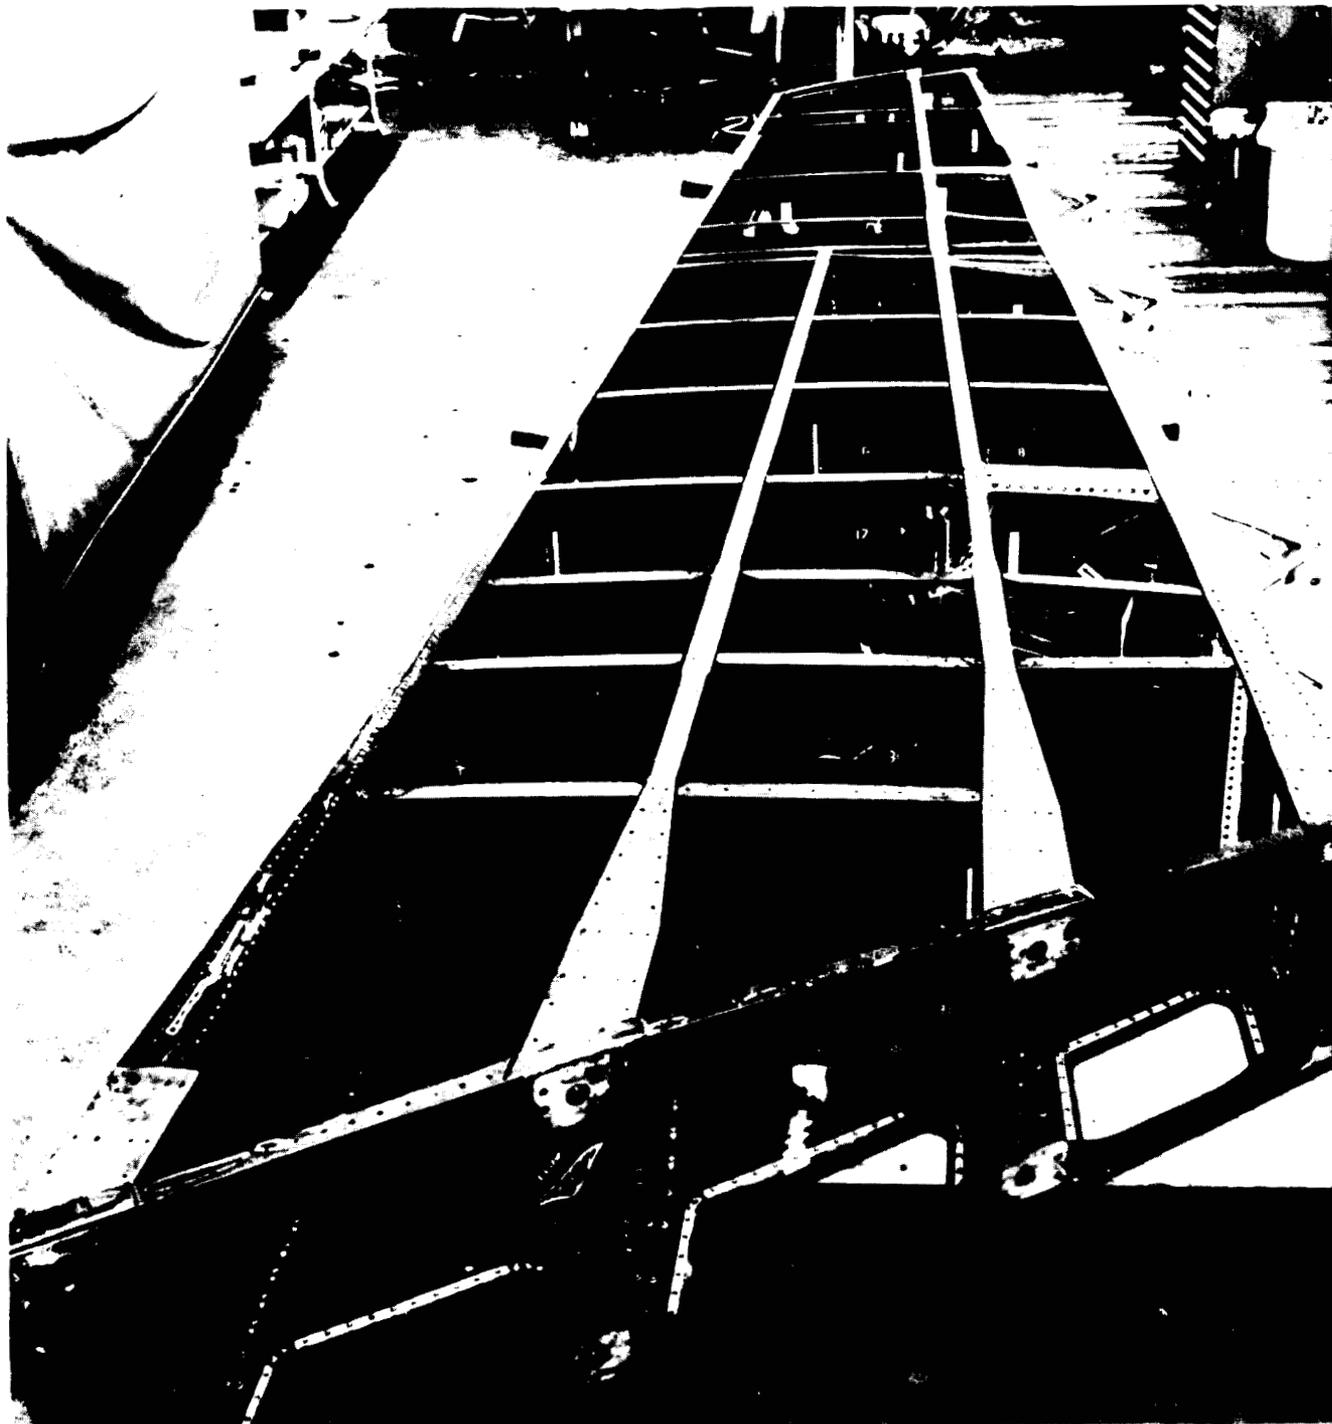
FIGURE 20. GROUND TEST UNIT AFTER TEST FAILURE WITH LEFT HAND SKIN REMOVED

The left-hand (compression side) skin panel was first inspected ultrasonically to detect any invisible damage. No significant damage other than that apparent by visual examination was found. This skin panel was then removed to allow a more detailed inspection of the damage to the substructure. Figure 20 is a view of the substructure after removal of the skin panel.

Failures were noted in the rear spar web and caps above the lower actuator cutout, the aft center spar web and caps, the forward center spar and front spar webs, and in a number of rib webs. Figure 21 is a sketch showing the location of the failed members in the substructure.

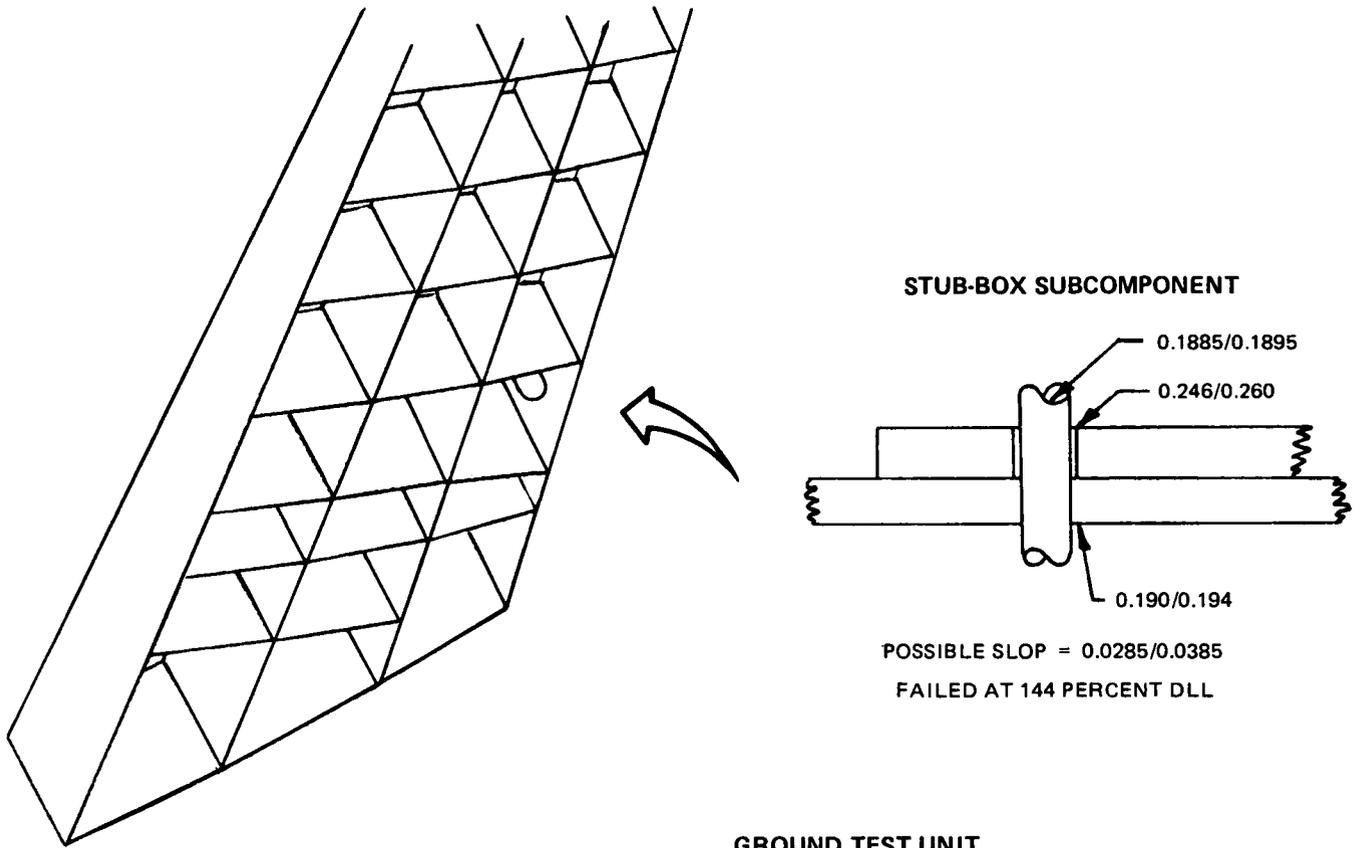
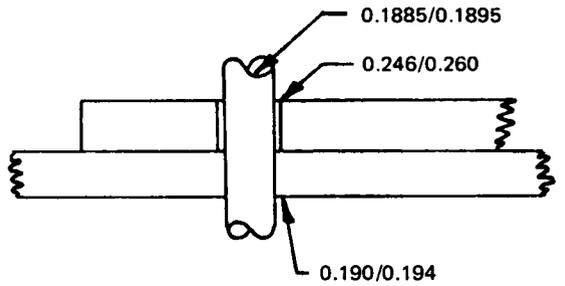
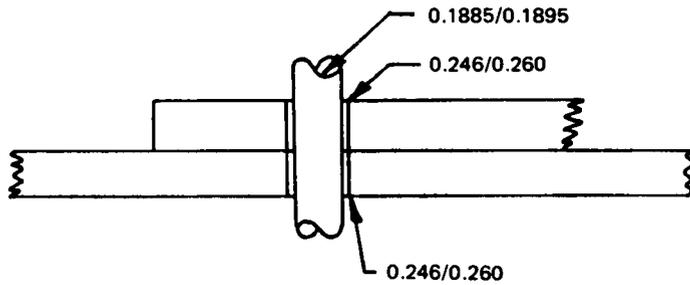
FIGURE 22. FASTENER FIT IN CRITICAL REAR SPAR WEB DOORS

1. The rear spar web in both specimens has a 4- by 5-inch hole at ZFR Station 342. This hole is reinforced by a cover plate attached with 12 fasteners. In the stub box, the holes in the rear spar web were of the appropriate size for the fasteners but the holes in the cover plate were 0.057- to 0.072-inch oversize. In the GTU the fastener holes in both the web and the cover plate were 0.057- to 0.072-inch oversize (Figure 22).

POSSIBLE SLOP = 0.0285/0.0385
 FAILED AT 144 PERCENT DLL

POSSIBLE SLOP = 0.0565/0.0715
 FAILED AT 100 PERCENT DLL

1. The failure of the rear spar web occurred as the result of higher-than-expected strains at the perimeter of the access opening in the rear spar web.
2. The strains were higher than analysis values because the cover over the access opening was not picking up load as designed.

3. The cover failed to pick up load as a result of improper quality of fit in the fasteners attaching the door to the web.

The relative quality of fit of the GTU and stub box specimens was considered to be the reason for the significant difference in failure load between the two.

The rework required to correct the initial failure condition had to eliminate the fastener fit sensitivity (including the effects of in-service wear) while retaining both the inspection access and weather protection features. At the same time, the rework had to be usable on parts that had already been built. The configuration that satisfied these constraints was a flat cover plate with a small reinforced flanged hole, bonded in place over each unreinforced access hole (Figure 30). By bonding the plate to the web, the effects of wear are eliminated, while the existing attachment fasteners, with improved fit quality, provided a fail-safe load path to protect against possible environmental degradation of the bond line.

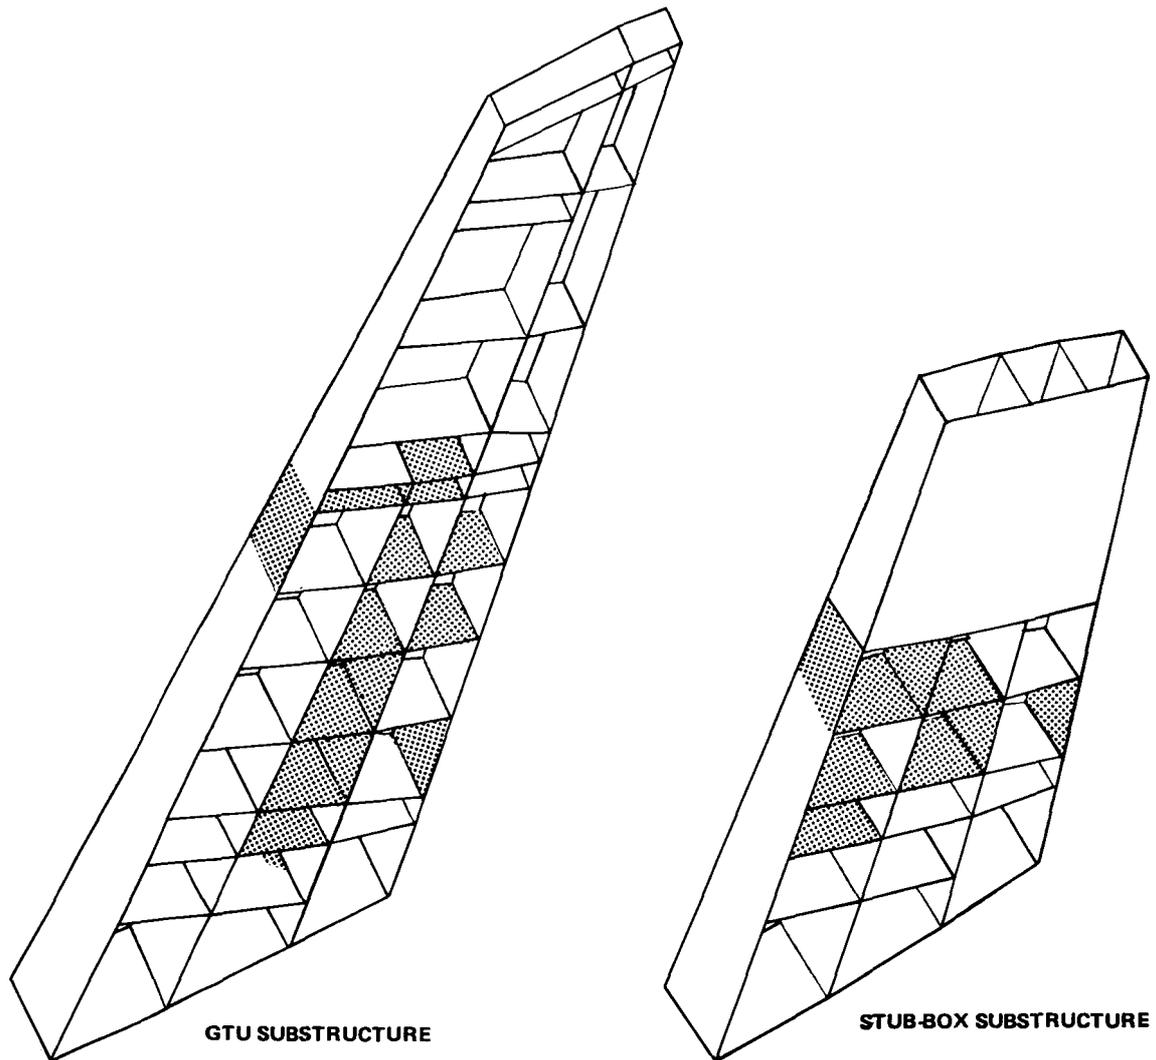
FIGURE 23. COMPARISON OF TEST FAILURE LOCATIONS IN STUB-BOX AND GTU SUBSTRUCTURES

Figure 23 is a comparison of the failure locations in the GTU substructure to those in the stub box subcomponent. The failed areas are in similar locations and differ only because of the influence of the boiler-plate dummy extension structure in the stub box.

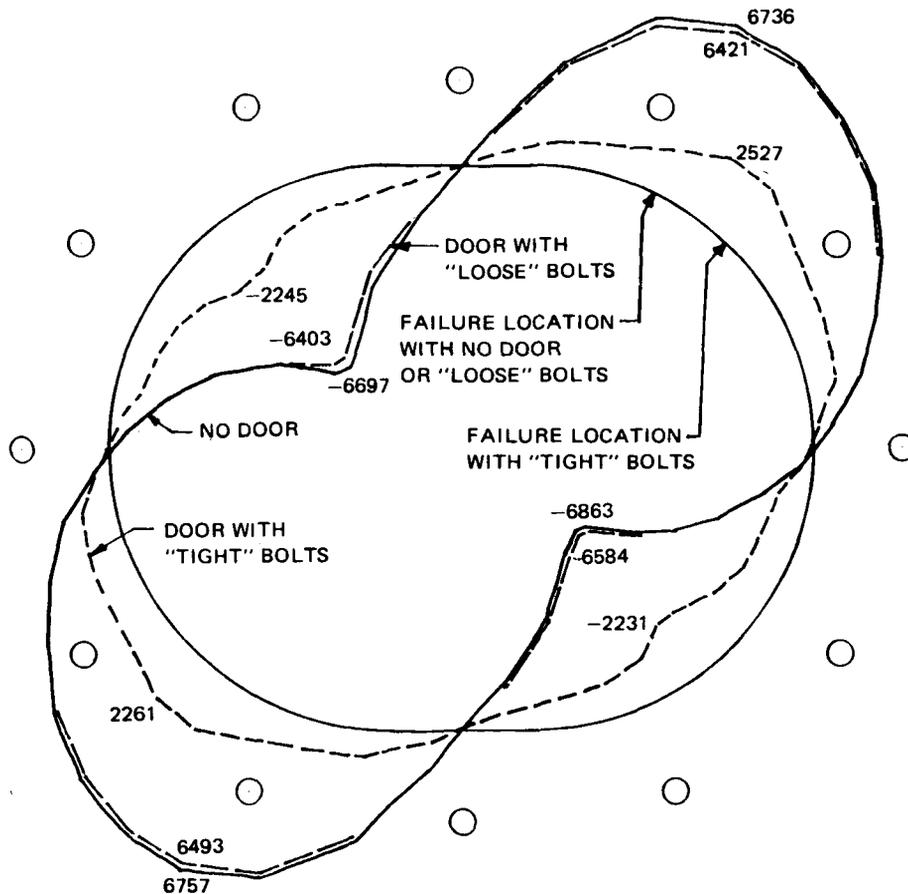
FIGURE 25. LAMINATE MIDPLANE STRAINS AT REAR SPAR WEB ACCESS OPENING

The second area of investigation was the covered cutouts in the rear spar web and the center bay of the Z_{FR} Station 314 rib. A simple planar analysis indicated that the strains at the perimeter of the cutouts were not critical even with the door missing. However, it was recognized that the sine wave web produces significant out of plane forces at the hole which would modify those results. Accordingly, a detailed three dimensional NASTRAN model of the critical rear spar web was developed (Figure 24). Web shear, spar cap and bolted joint interface loads were applied to the model while the attachment of the door module to the web module was analytically varied from full shear effectivity to zero shear effectivity. A reference case with no door installed was also run. The results are shown in Figure 25, where the laminate mid-plane strains at the perimeter of the access opening are plotted for each quality of fastener fit. Clearly, if sufficient slippage between the door and web is available, the presence of the fasteners provides almost no relief from the maximum strains, while fully effective fasteners (i.e., a fully effective door) provides considerable support at the edge of the cutouts.

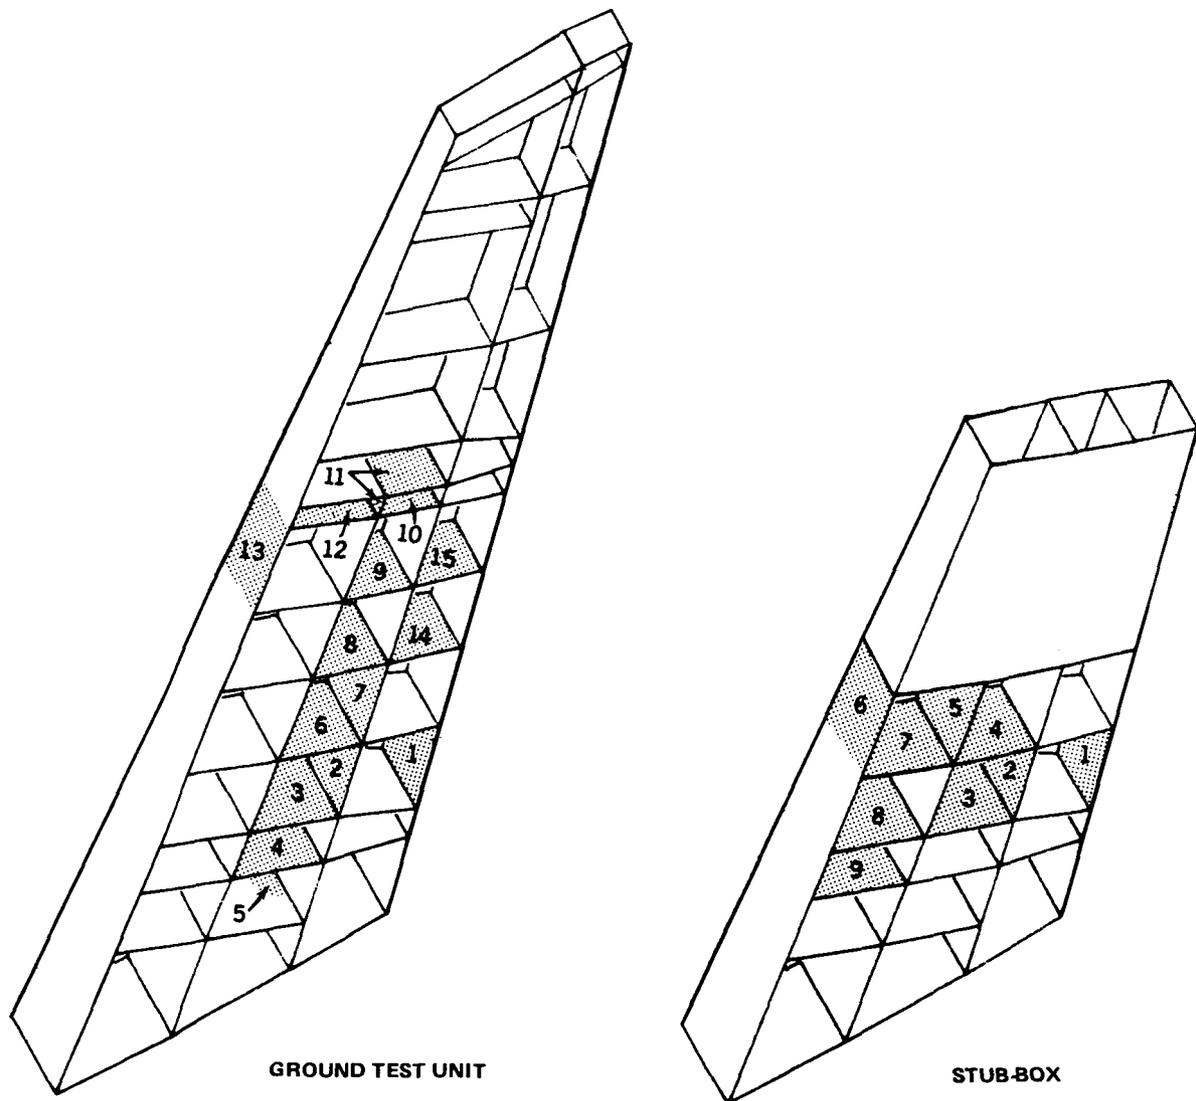
FIGURE 27. ANALYTICAL FAILURE SEQUENCE

The NASTRAN model for the stabilizer was modified to reflect an assumed failure in the rear spar web at Z_{FR} Station 342 and was subjected to the appropriate load condition (maximum bending case). This analysis indicated a progression of failure to the aft center spar web between Z_{FR} Stations 329 and 350. This failure progression was pursued analytically with the finite element model to determine the probable sequence of failure. Each structural element that subsequently indicated a negative margin was deleted from the model and the loads reapplied. A search was then made for negative margins in the remaining structure. In this fashion, a probable failure sequence was established for both test articles as shown in Figure 27. Each distinctive structural failure observed in the substructure of both test articles was predicted by this analysis.

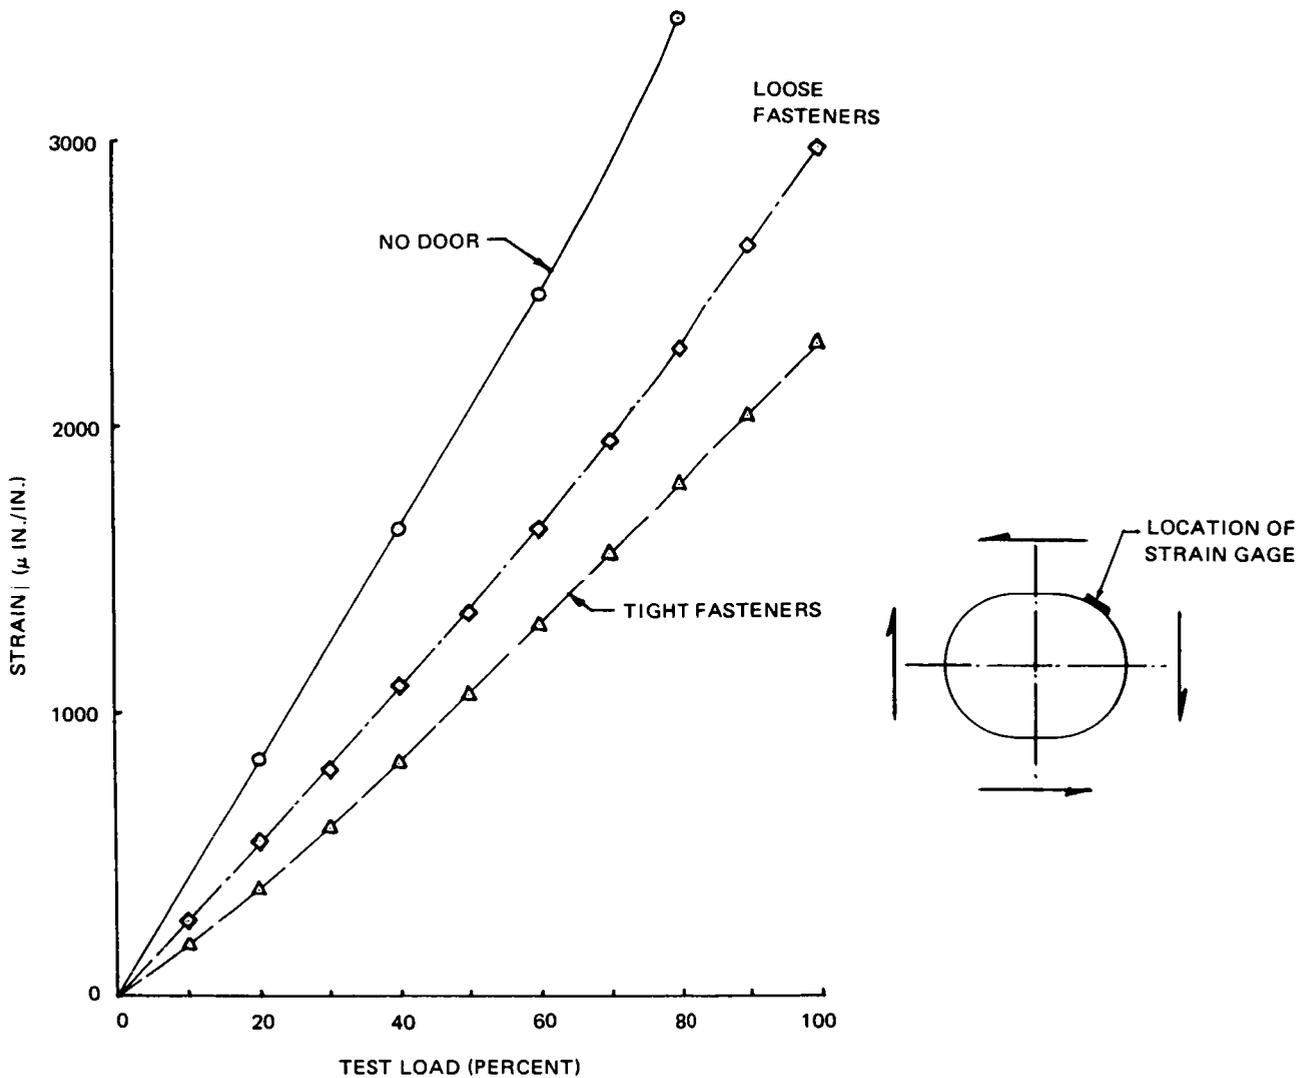
FIGURE 29. STRAIN AT PERIMETER OF CUTOUT IN AMC7855-5 RIB COMPONENT

The results of these tests are shown in Figure 29, where the maximum strains measured at the perimeter of the access opening are plotted versus load. Without a door attached, the hole perimeter strains were extremely high. With the tight fit holes, the perimeter strains were considerably reduced. When the door holes were drilled out, the strains increased, as was expected. When the web holes were drilled out (not shown) no additional effect was observed. This is consistent with the failure theory, in that once the fasteners lose contact with the holes, additional clearance can do no additional harm. Only after sufficient distortion had occurred to bring the intermediate fit configuration fasteners into contact with their holes would any difference become apparent. This load level was not reached during the test due to the risk of prematurely damaging the specimen.

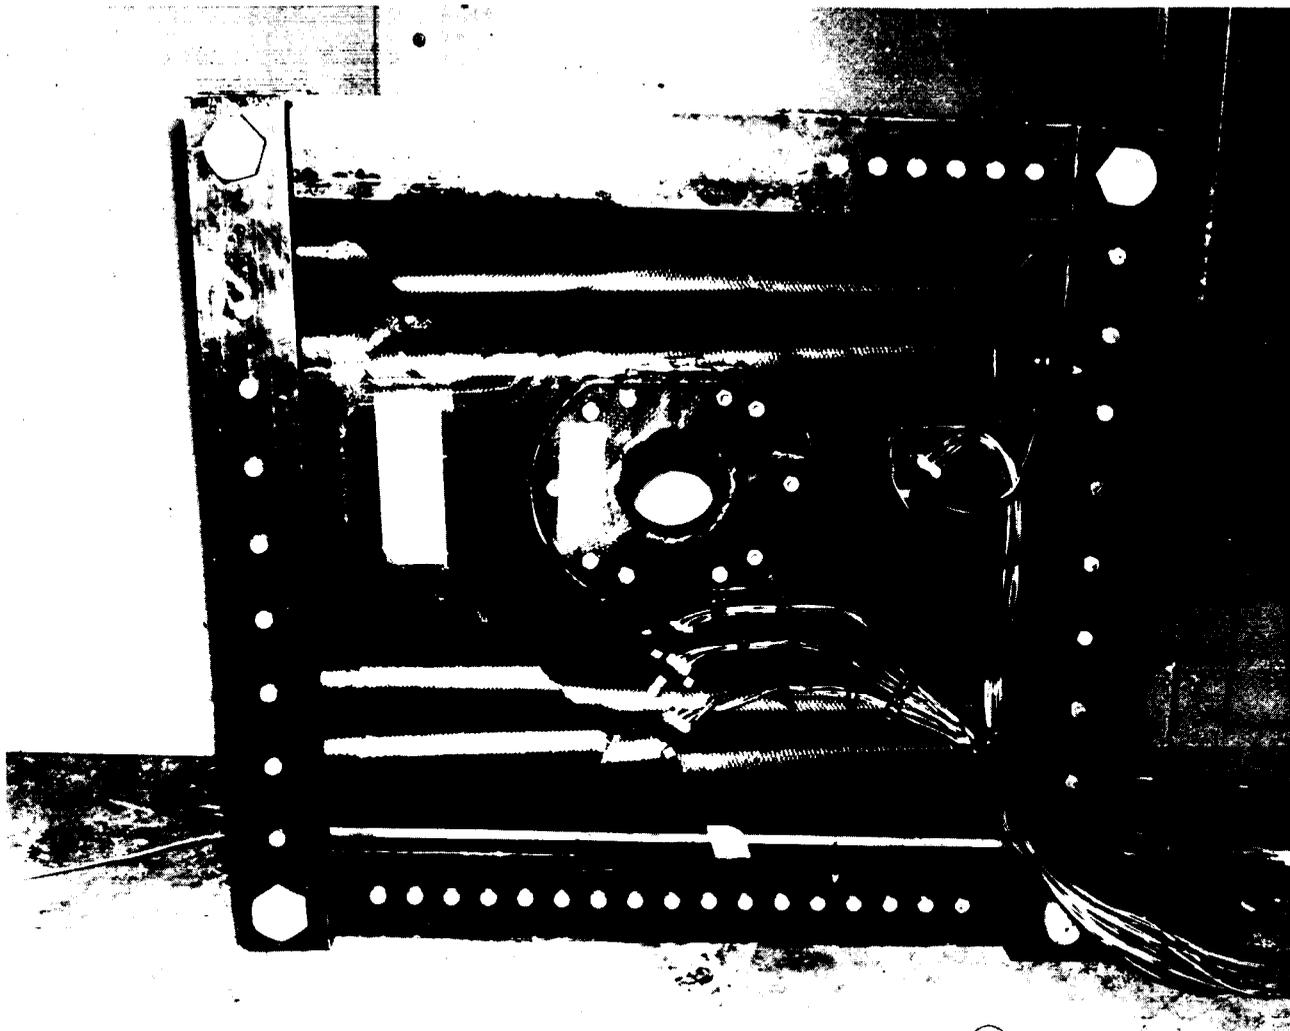
FIGURE 32. AMC7855-5 RIB COMPONENT AFTER TEST SHOWING WEB FAILURE

To test the validity of the concept, a flanged plate was made and installed on the AMC7855-5 rib test specimen (Figure 31). The panel was tested to failure, with failure occurring in the basic sine-wave web, well away from the opening (Figure 32). The strains measured at the perimeter of the hole with the bonded cover in place are shown in Figure 33.
